# Field Report

**Customer / Project information** North Cornwall District council - Fish Ponds

To provide a waterproof lining to the leaking fish ponds

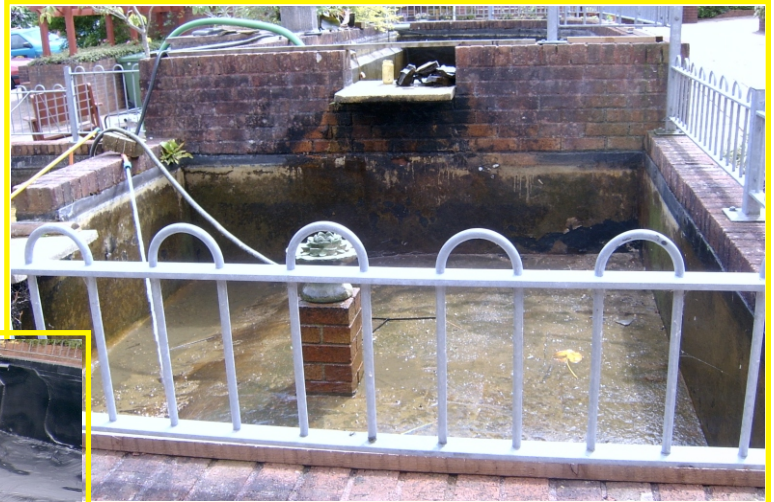
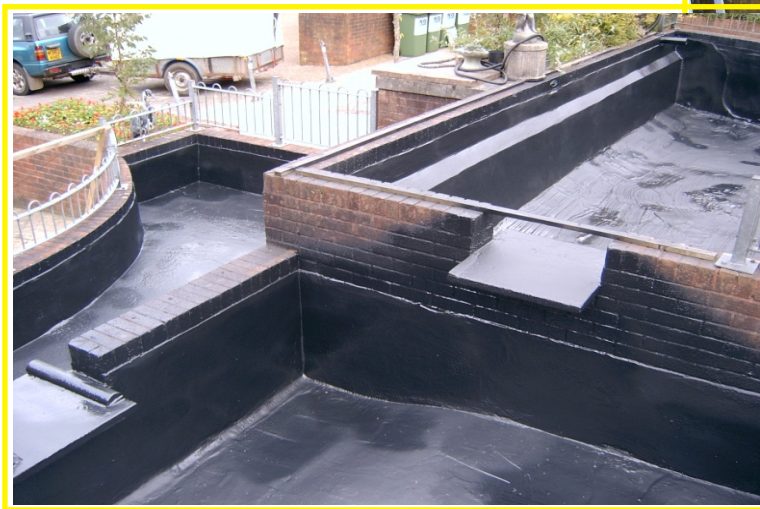
The fish ponds were severely leaking resulting in the increase of the water bill by £10,000 per quarter. The leak could not be detected at one single point so a full lining system was required. As this is the third time in as many years that North Cornwall District Council has had to re-line the ponds a guaranteed long term liner was now required.

The substrates were pressure washed to remove grime & lose debris then allowed to dry, The substrate was then scuffed up with wire brushes to gain a key. LINE-X SF5-15 (CFC, VOC & Solvent Free) primer was applied by spray & allowed to cure. LINE-X Acuaurethane Rapid was then applied to a minimal thickness of 3mm.

We chose to go a bit further & encapsulate the waterfalls in LINE-X as this removed the danger of the ponds leaking from these areas.

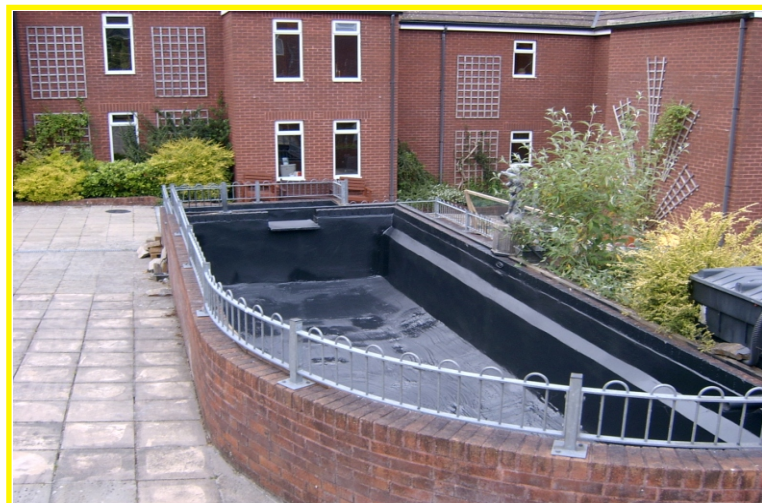
The job took 10 hours to complete, With the fast cure times (tack free between 3-5 seconds & full cure hardness in 24 hours) these ponds were filled & re-stocked with fish the following day.
